Volunteer Home Repair Program (Request for Quotes)
 Deadline: Thursday, September 25, 2014

City of Brunswick
 Department of Community Development
 601 Gloucester Street, 2nd Floor, Room 221
 Brunswick, GA 31520

Inspection Report

Property Address:
1102 Q Street
Brunswick Ga 31520

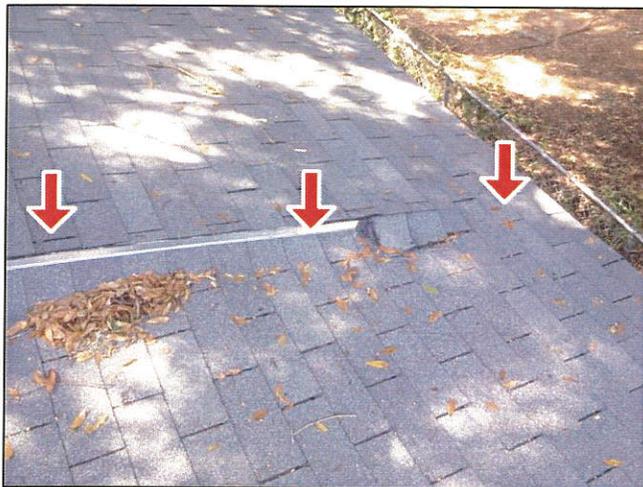
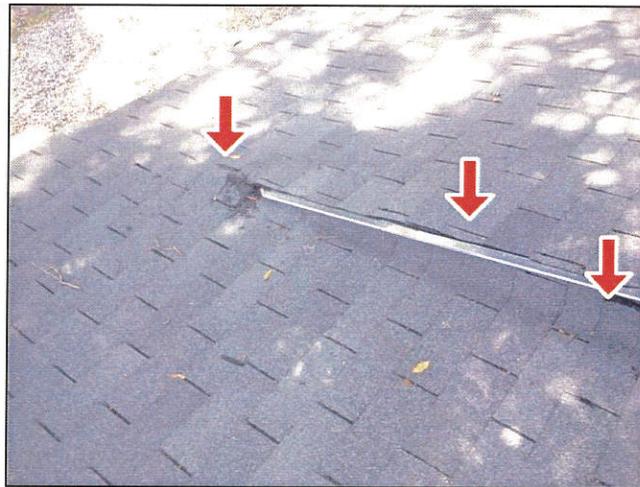
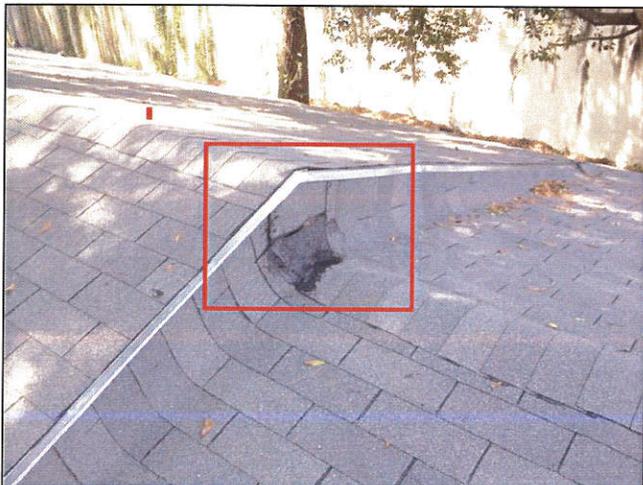
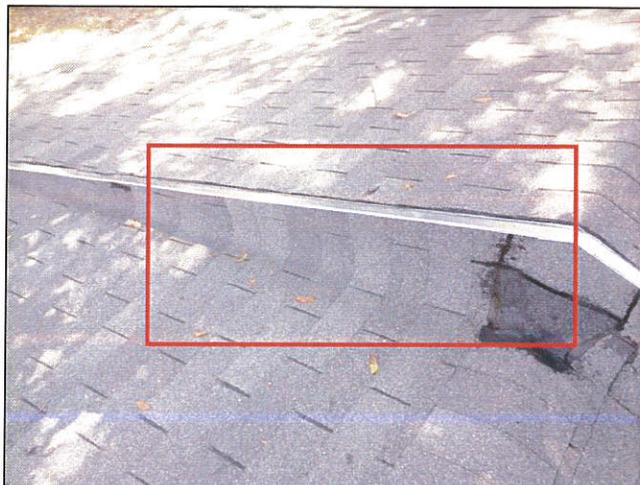
**1.1** Porch roof transition improperly flashed at the front of home. Repairs are needed. Recommend a qualified roofing contractor repair as needed.

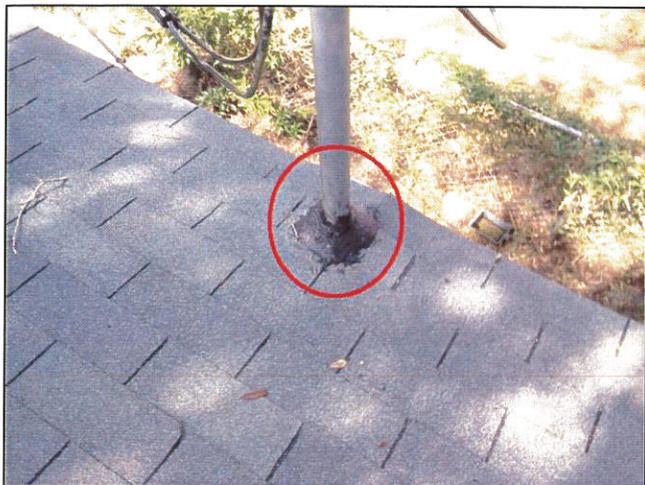
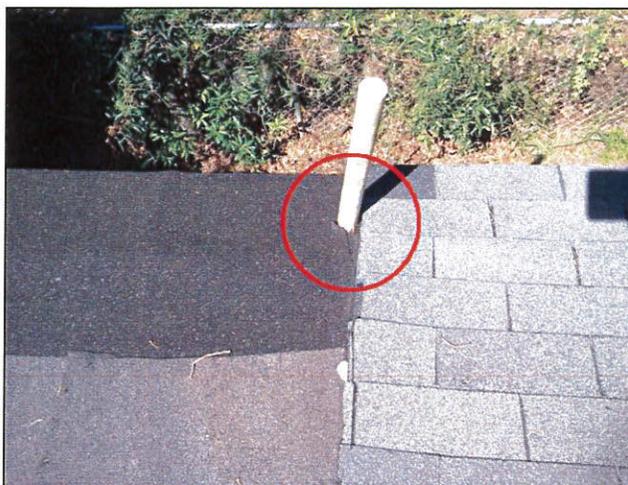
**1.2** Weatherhead and vent pipe at rear flat roof missing boots. Recommend a qualified roofing contractor repair as needed

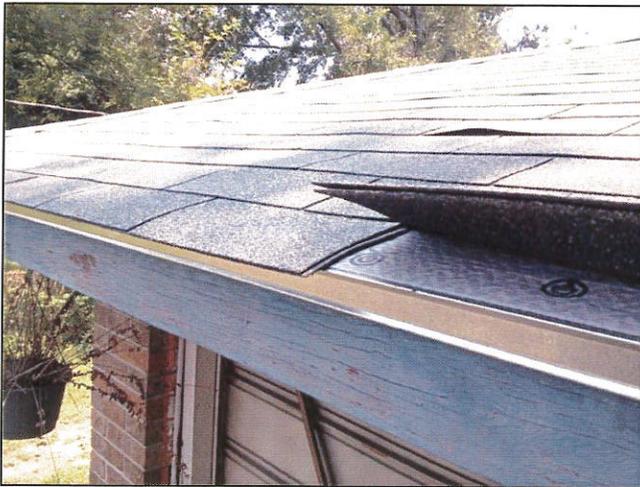
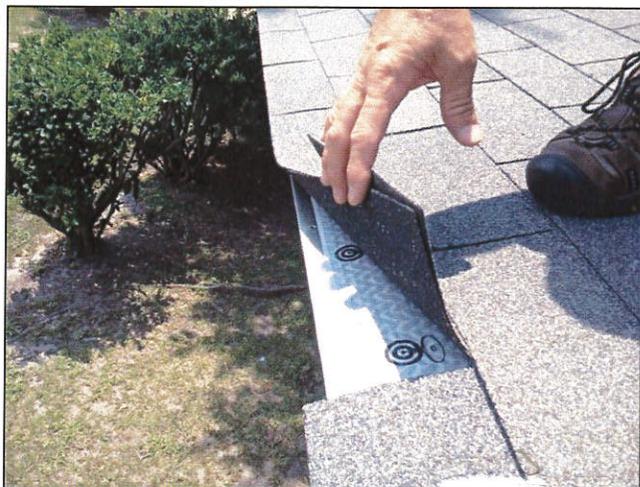
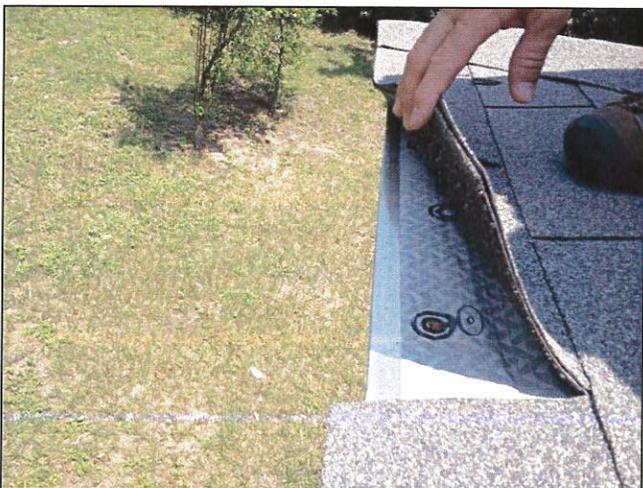
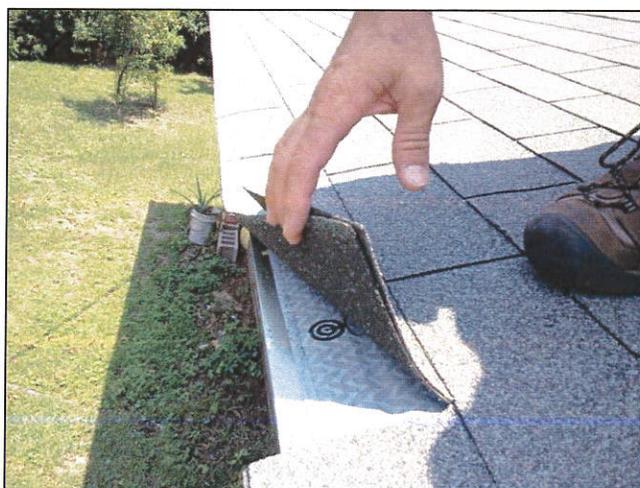
**1.0** Starter strip and first row of shingles are not properly offset at various places around eaves. Recommend a qualified roofing contractor repair or replace as needed.

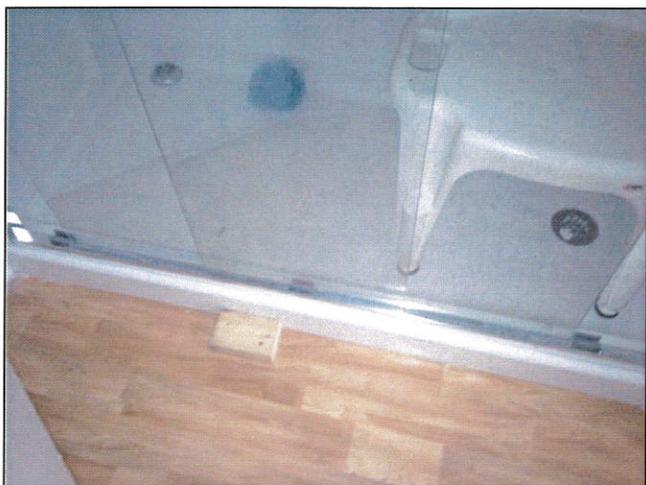
1.4 Item 1(Picture)

**1.4** Sliding shower door does not work in track properly and in need of adjustment. Recommend a qualified contractor repair as needed.

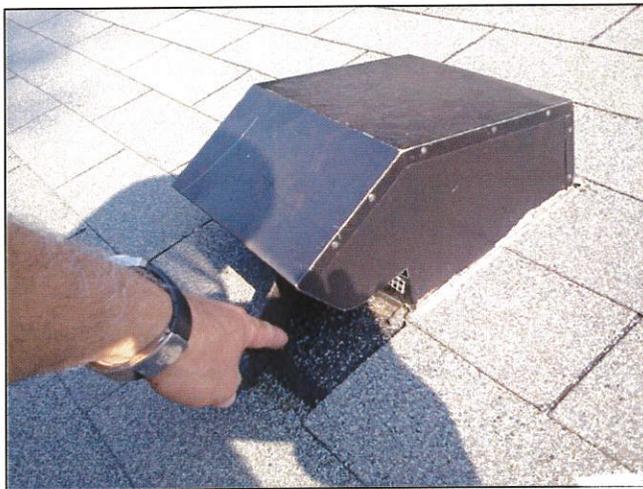
1.2 Item 1(Picture)

**1.2** One passive roof vent hood flange installed under bottom shingle roof beneath hood. Recommend a qualified roofing contractor repair as needed.

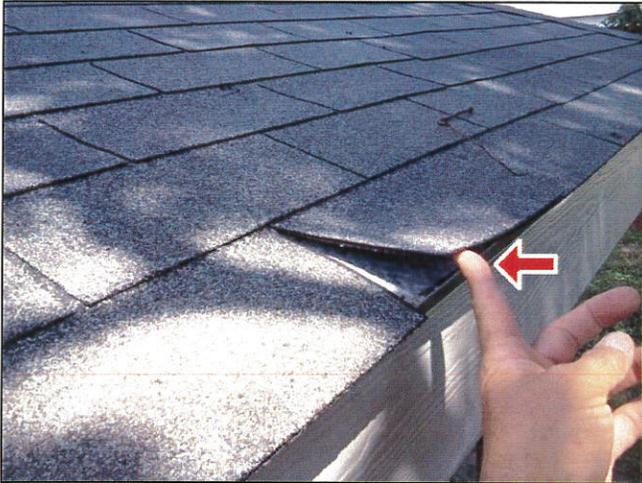
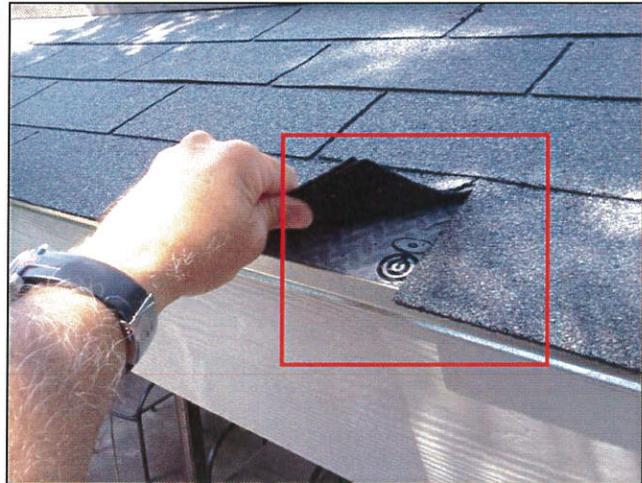
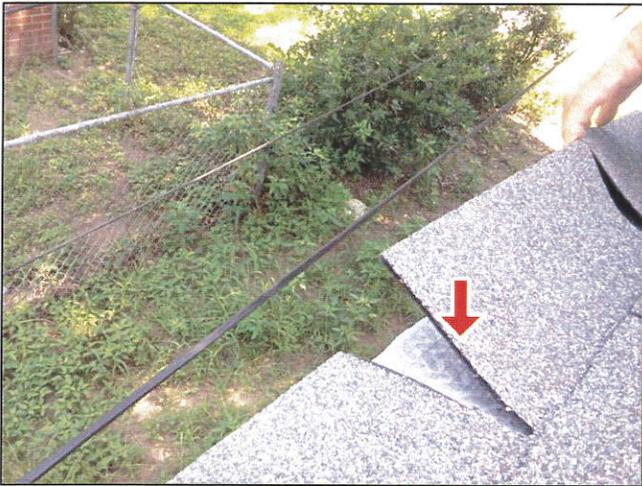
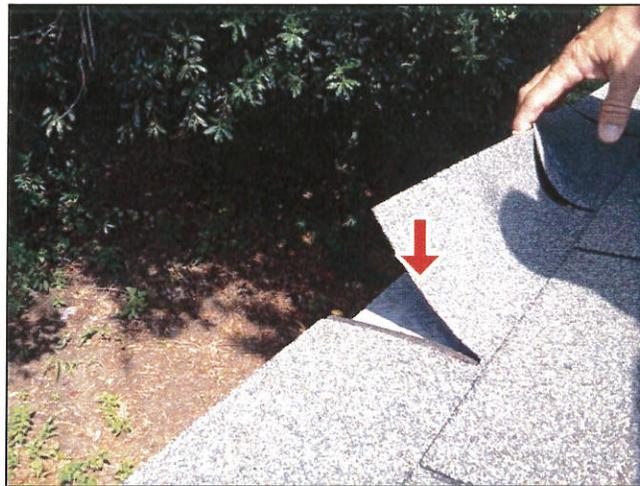
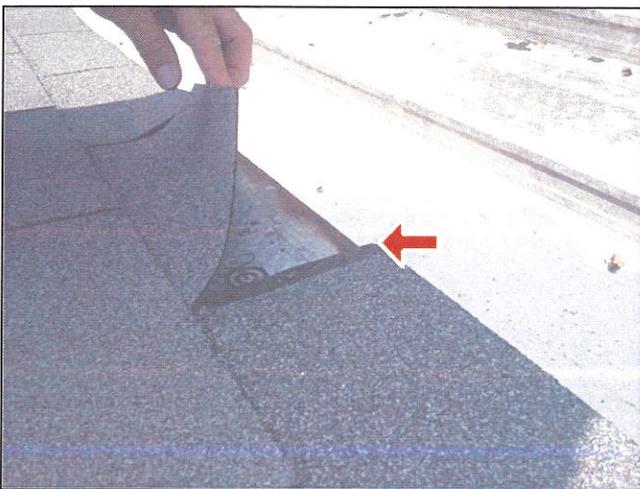
**1.0** Starter strip and first first row of shingles at not offset at joints. Recommend a qualified roofing contractor repair as needed.

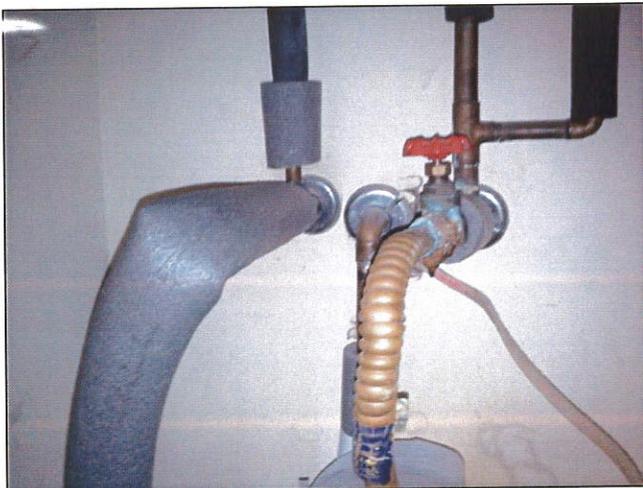
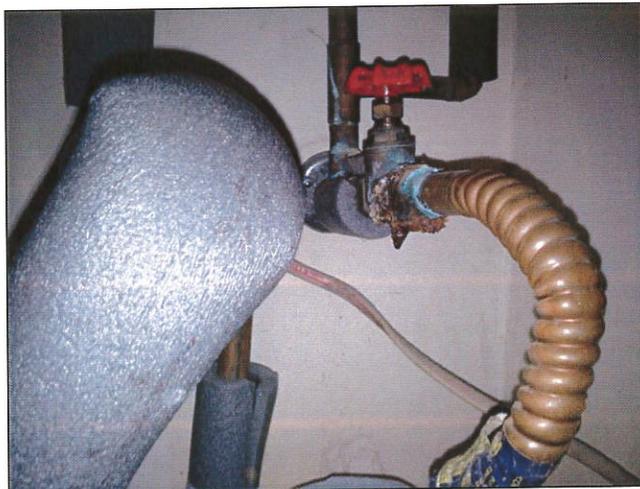
**1.0** Supply valve at water heater corroded and actively leaking in home and considered an emergency repair issue. Water heater is over 15 years old and deteriorated. Recommend a supply valve and water heater be replaced by a licensed plumbing contractor
